## Ceramic femoral head fracture with massive metallosis and severe wear of the cone: a case report and review of the literature

**Abstract** A case of a fractured ceramic femoral head without subsequent trauma, 14 months after a primary total hip arthroplasty, in a 40-year-old woman with hip dysplasia is reported. Intraoperative findings were multifragment femoral head and a damaged polyethylene insert along with diffuse metallosis and excessive wear of the cone of the stem. Both the stem and the acetabular component were stable. After the removal of ceramic fragments, metallosis excision and careful lavage of the joint, the inlay was replaced by a similar one and a cobalt–chromium femoral head was placed to the existing notched taper of the firmly incorporated stem. At 22-month follow-up examination, the patient had no pain, used no walking aids and had normal activity.

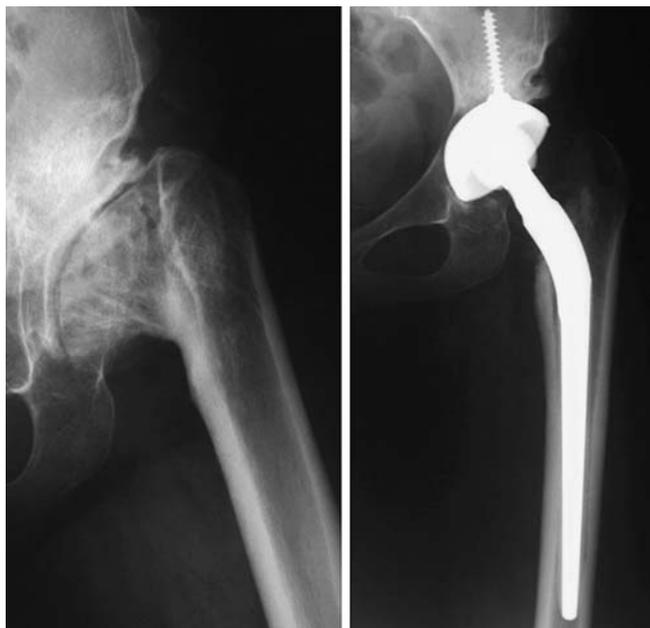
**Fig. 1** Preoperative plain radiograph showing a dysplastic hip with secondary degenerative osteoarthritis. At 12-month follow-up evaluation, there are no signs of loosening or other implant-related pathology

instructions. The head was placed with a twisting motion and gently impacted twice, with a femoral head inserter. During the sixth and twelfth month evaluation the patient had no symptoms of pain and the hip motion was excellent (Fig. 1). In February 2003, she was referred back to the orthopaedic outpatient office complaining of right groin pain and crepitus, with no history of trauma. Radiographs showed a multiple fragmented ceramic head and significant notching of the cone (Fig. 2, arrows).

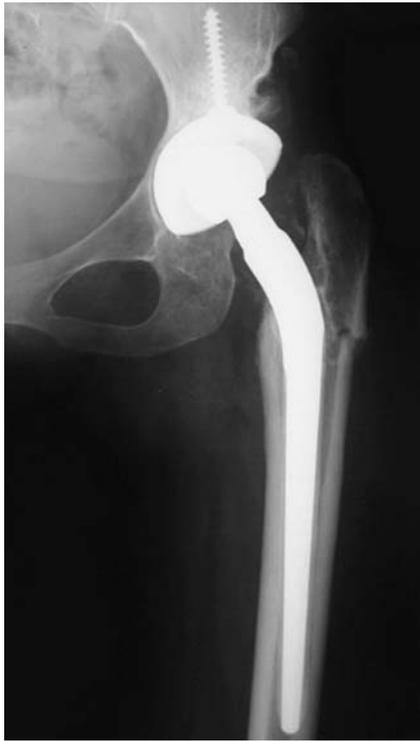
**Fig. 4** Normal plain radiograph of the involved hip 22 months after the revision operation

aids and had normal activity without any signs of loosening or other implant pathology in plain radiographs (Fig. 4).
